Reducing the fatal entrapment of marine turtles in towed seismic survey equipment

Ketos Ecology (2007). Reducing the fatal entrapment of marine turtles in towed seismic survey equipment. Ketos Ecology report, 11 pp. Document available online at: www.ketosecology.co.uk/KE2007.pdf

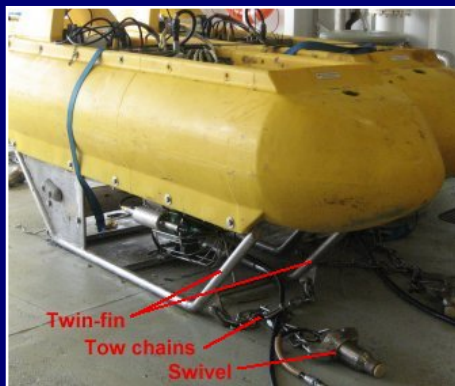
Figure 5. A tail buoy on deck, showing the twin-fin design, swivel and tow chains

The gap below a typical tail buoy (e.g. Figure 5) extends to 0.8 m below water level, and is approximately 0.6 m in width. The potential for a turtle to become stuck within this gap will therefore depend on the size of the animal. It would need to be small enough to enter the gap, but too big to pass all the way through the undercarriage.

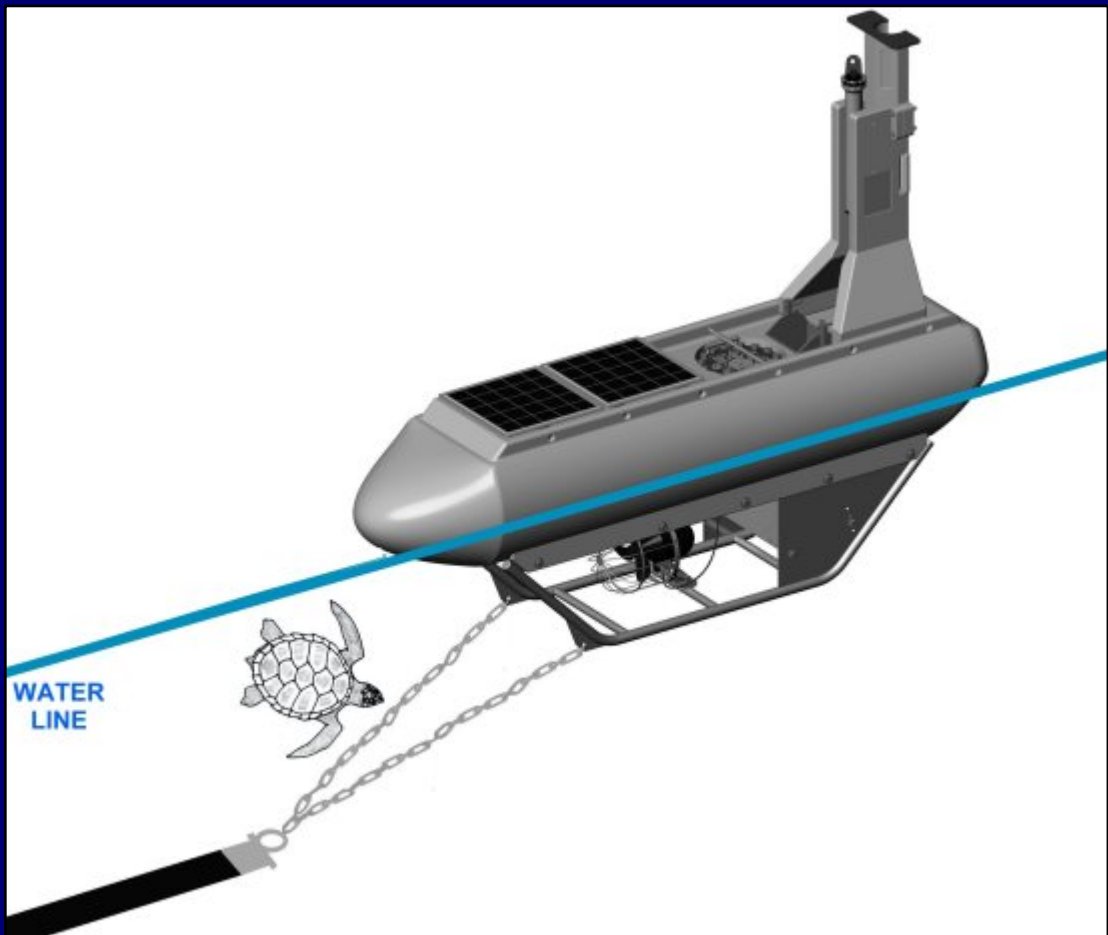
Startle dives are usually observed when a turtle is basking at the water surface for metabolic purposes during hot, calm weather. Basking behaviour appears to make turtles slow to react to approaching threats, with startle dive reactions occurring only at close range (often within a few metres) to approaching objects and apparently based principally on visual detection. Turtles have been observed startle diving in reaction to towed seismic equipment (paravanes and dilt floats) and to seismic vessels themselves (Weir, 2007). A turtle that startle dives in response to an approaching tail buoy will be in a prime position for entrapment (Figure 7).

Figure 7. Schematic of a turtle that has startle-dived in response to an approaching tail buoy

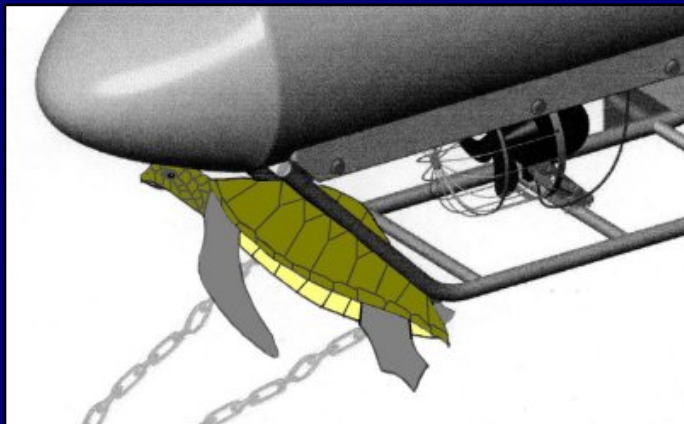
- (A) in front of the undercarriage in the area between the buoy and the towing chains; and
- (B) between the 'twin-fin' undercarriage structure:

The attachment of the tow chains to the tail buoy undercarriage results in the creation of an angled gap between the chains and the underside of the buoy. Seismic crew have reported large turtles becoming stuck within this angle, lying across the top of the chains and underneath the float. Often, these turtles are trapped with their ventral (under-) surface facing the oncoming water, resulting in considerable drag and causing the turtle to be held firmly in position and the tail-buoy to tow awkwardly.

- Re-locating the towing chains to the front of the buoy undercarriage to remove the tight angle between the chains and the undercarriage where turtles are known to get caught (Section 2.1.3). Ideally, the use of a single tow chain would greatly reduce the potential for turtle entrapment. However, gun mechanics indicate a strong preference for having two tow chains for the reasons of logistical handling and for safety should one of them fail. Effort should be made to consider alternative mechanisms of towing that would present less danger for turtles

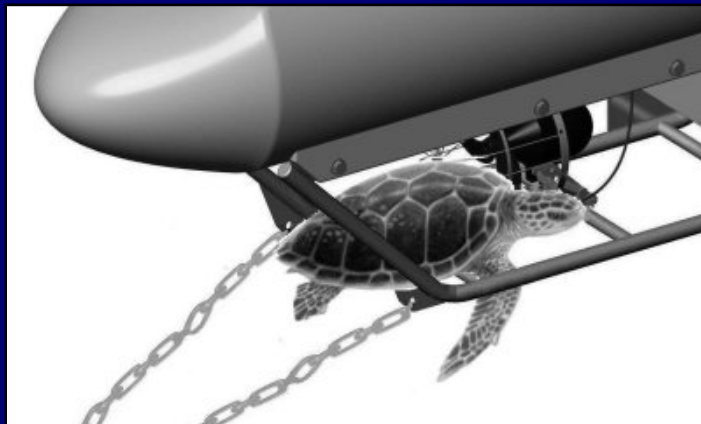
(B)

The presence of the propeller in some buoy designs prohibits turtles that have entered the undercarriage from travelling out of the trailing end of the buoy. It is unclear at this stage in what position turtles trapped here are orientated, i.e. whether they enter the structure head-first or tail-first and whether they are upright or upside-down.

- Removing or reducing the subsurface undercarriage. This would be the most obvious solution to prevent turtle entrapment. However, it is recognised that some subsurface structure is needed to counter-balance the otherwise top-heavy design of tail buoys. The possibility of designing a buoy with a single keel should be explored, particularly since the presence of solar panels on most buoys now reduces the need for the underwater propeller unit. The advantage that the twin-fin design offers for upright storage is considered surplus since it is not utilised on many ships (see Figure 6)

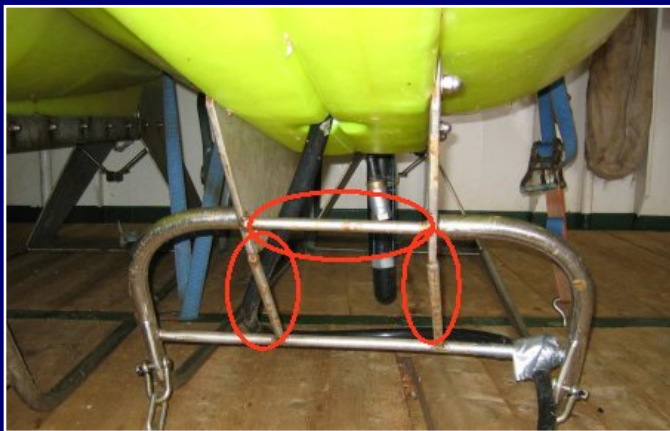
Figure 9. Simple exclusion 'turtle guard' design (the added structures are circled in red)

This design is simple to produce, and does effectively address one of the known sites of turtle entrapment. However, this design may not eliminate the possibility of turtle entrapment between the tow chains and the undercarriage as has been reported to occur in some surveys (Section 2.1.3).

Design 1. On this tail buoy three simple exclusion bars have been welded across the large gap between the twin-fins and the horizontal joining stiffener to exclude turtles from entering the gaps.

- Removing surplus parts of the tail buoy undercarriage (e.g. the horizontal joining stiffener, Figure 9) which have no obvious role and create extra gaps where turtles could become trapped

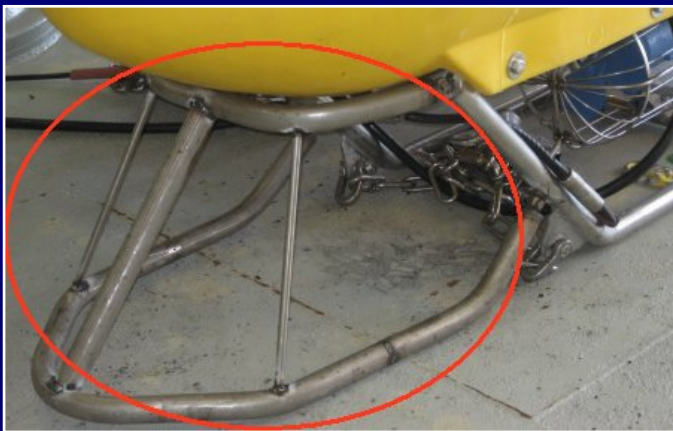
Figure 10. Forward-projecting turtle guard design (the added structure is circled in red)

This design is slightly more complex to produce but is potentially more effective since it addresses both locations of turtle entrapment described in Section 2.1.3. The gun mechanics also indicated that this design made at-sea maintenance of the tail buoy more efficient, due to being able to lift the extended front portion of the buoy on to the stern of the workboat.

Design 2. This turtle guard projects forward from the tail buoy undercarriage to push turtles out of the way before they can enter the gap between the twin-fins or get stuck in the angle between the tow chains and the buoy.
