'TURTLE GUARDS': A METHOD TO REDUCE THE MARINE TURTLE MORTALITY OCCURRING IN CERTAIN SEISMIC SURVEY EQUIPMENT

During 2007 Ketos Ecology released a document entitled 'Reducing the fatal entrapment of marine turtles in towed seismic survey equipment' ([Ketos Ecology, 2007](#)), which outlined the issue of accidental mortality of endangered marine turtles occurring in seismic tail buoys. The document contained information on the mechanism of turtle entrapment in this equipment and made recommendations for minimising the problem via the use of 'turtle guards' that could be fitted to the front of seismic tail buoys to prevent turtles from becoming trapped. During October 2007, this document was distributed to the IAGC, the OGP and various seismic regulatory authorities with the aim of raising awareness and finding a long-term solution to the problem.

During 2008/09, it has become apparent that the turtle guards designed and implemented by certain seismic contractors do not eliminate turtle mortality in tail buoys. It also became apparent that not all designs of seismic tail buoy trap turtles; the problem is restricted to particular designs used by certain seismic contractors. Conseque

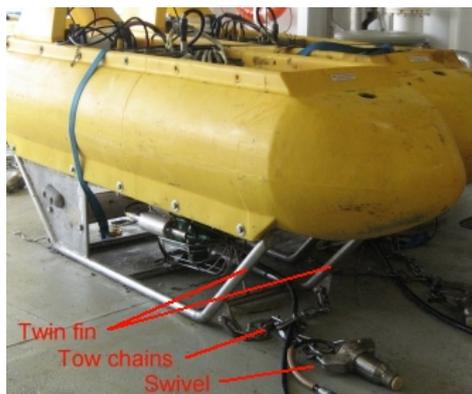
Figure 5. A tail buoy on deck, showing the twin-fin design, swivel and tow chains

The gap below a typical tail buoy (e.g. Figure 5) extends to 0.8 m below water level, and is approximately 0.6 m in width. The potential for a turtle to become stuck within this gap will therefore depend on the size of the animal. It would need to be small enough to enter the gap, but too big to pass all the way through the undercarriage.

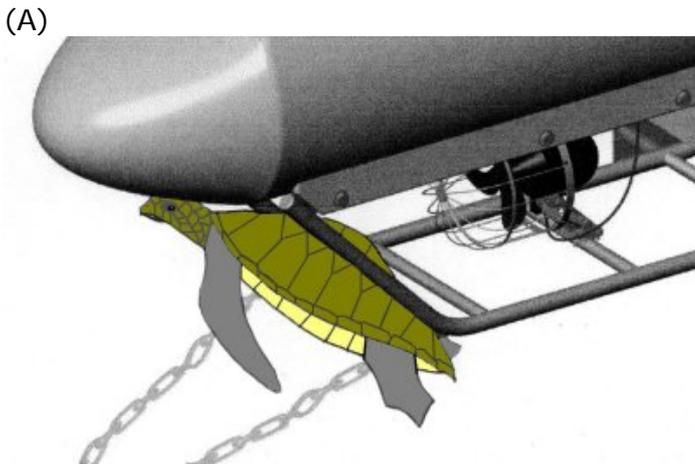
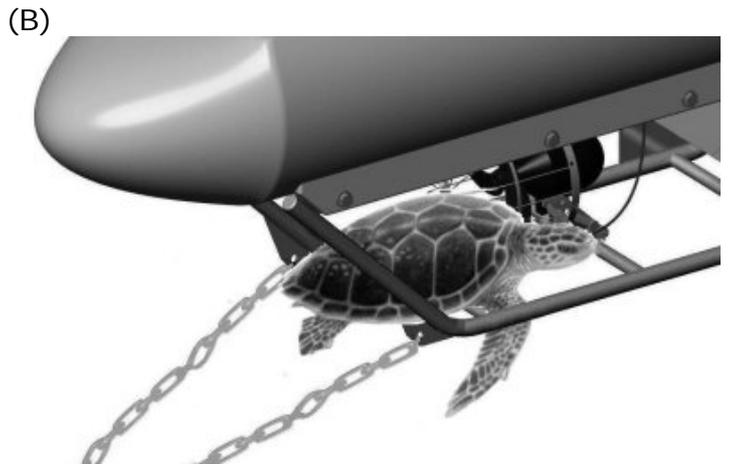
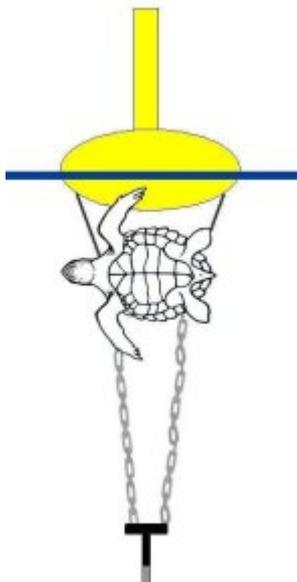
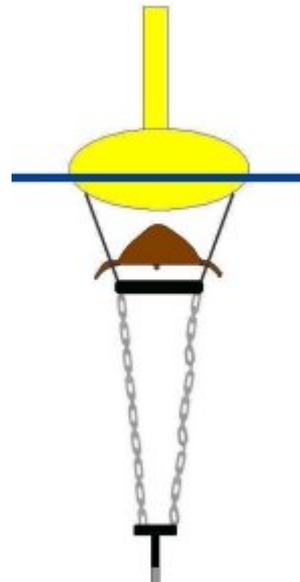
Seismic personnel have reported two areas of a tail buoy where turtles become trapped: (A) in front of the undercarriage in the area between the buoy and the towing chains; and (B) inside the 'twin-fin' undercarriage structure:

The attachment of the tow chains to the tail buoy undercarriage results in the creation of an angled gap between the chains and the underside of the buoy. Seismic crew have reported turtles becoming stuck within this angle, lying across the top of the chains and underneath the float. In all reported cases these turtles have been trapped on their sides, with their ventral (under-) surface facing the oncoming water, resulting in considerable drag and causing the turtle to be held firmly in position and the tail-buoy to tow awkwardly.

The presence of the propeller in some buoy designs prohibits turtles that have entered the undercarriage from travelling out of the trailing end of the buoy. It is unclear at this stage in what position turtles trapped here are orientated, i.e. whether they enter the structure head-first or tail-first and whether they are upright or upside-down.

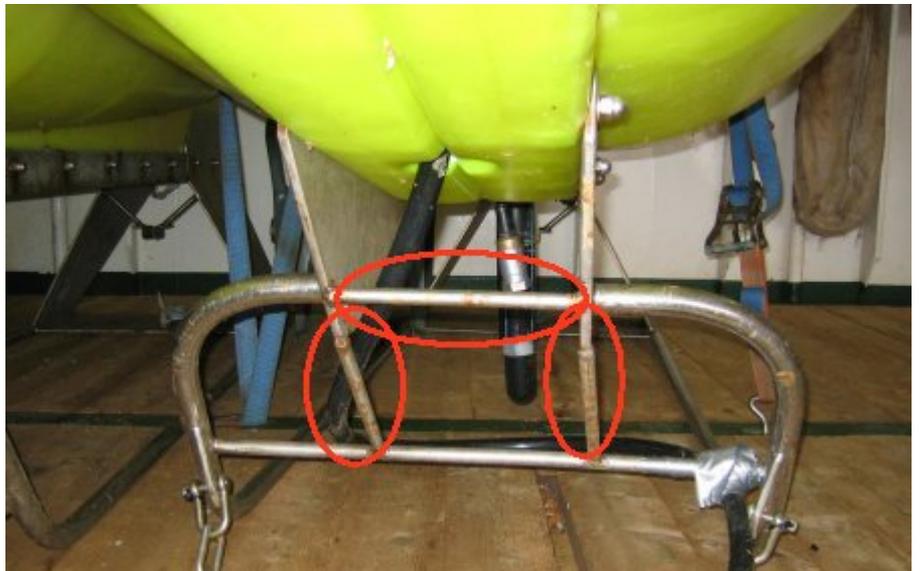
Design 1. Exclusion turtle guard

On this tail buoy three simple exclusion bars have been welded across the gap between the twin-fins and the horizontal joining stiffener to exclude turtles from entering the tail buoy undercarriage and becoming trapped.

This design is simple to produce, and does effectively address one of the known sites of turtle entrapment. However, it does not address the possibility of turtle entrapment between the tow chains and the undercarriage as has been reported to more frequently occur (Section 2.4).

Figure 9. Simple exclusion 'turtle guard' design (the added structures are circled in red)

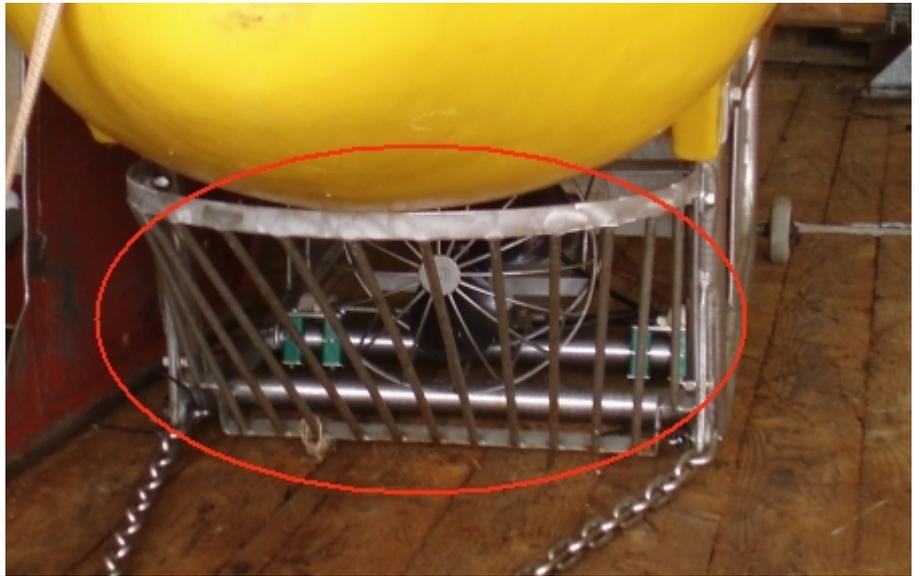
Design 2. Exclusion turtle guard

This tail buoy has been fitted with a pre-fabricated exclusion turtle guard that was shipped out and welded into place onboard the vessel. The guard consists of a series of closely-spaced vertical bars that prevent turtles from entering the gap between the twin-fin undercarriage.

This design does exclude turtles from entering the gap in the undercarriage. However, it does not prevent turtles from becoming trapped above the tow chains and in front of the turtle guard, as illustrated in Section 2.4.A.

Figure 10. Exclusion 'turtle guard' design (the added structure is circled in red)

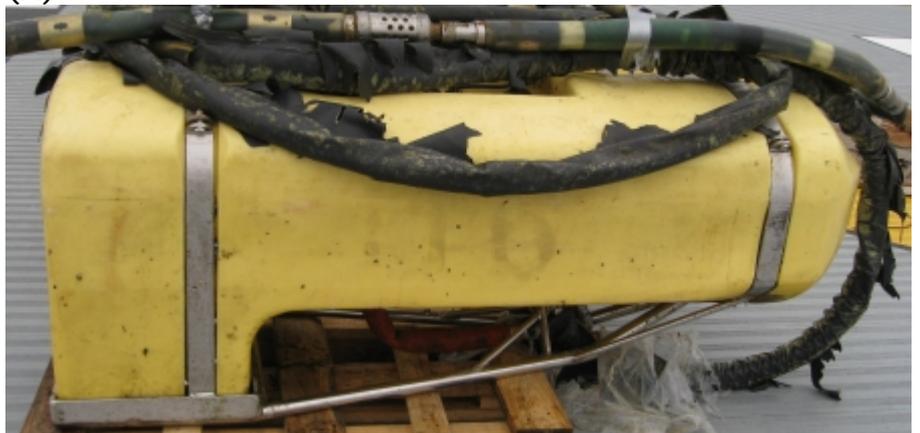
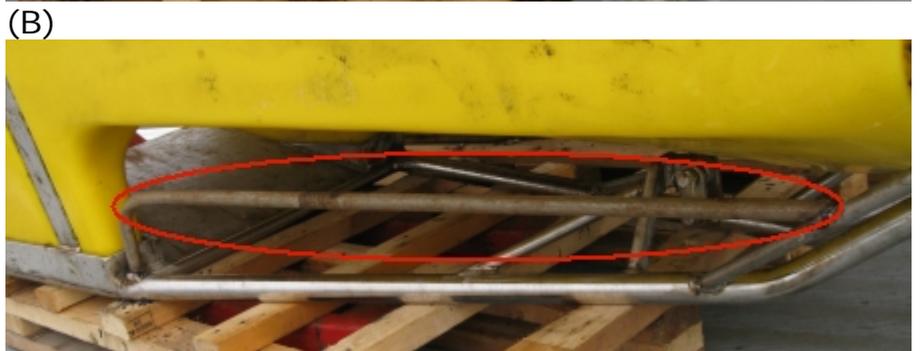
Design 3. Exclusion turtle guard (A)

The tail buoy shown here (Figure 11A) is of a design highly unlikely to trap turtles. The tail buoy lacks the prominent 'twin fin' of some other designs, having instead a front end that slopes backwards at a shallow angle to the under-carriage and would not cause turtles to be pinned against the front. Metal bars across the front also mean that turtles could not enter the under-carriage. Rather than having two tow chains across which turtles could become stuck, there is a single towing point. Turtles encountering this tail buoy should simply slide down the front of the buoy and move away without becoming stuck. There are no known instances of turtle mortalities using these buoys, and they are considered to be a **'turtle friendly'** tail buoy design.

However, as an extra precautionary measure a simple turtle exclusion guard has been welded across the gaps on either side of the tail buoy (Figure 11B) to exclude turtles in the unlikely event that they come into contact with the buoy from the side.

Figure 11. (A) A tail buoy design unlikely to cause turtle Mortality; and (B) an exclusion 'turtle guard' added along the side to prevent turtles entering the buoy (the added structure is circled in red)

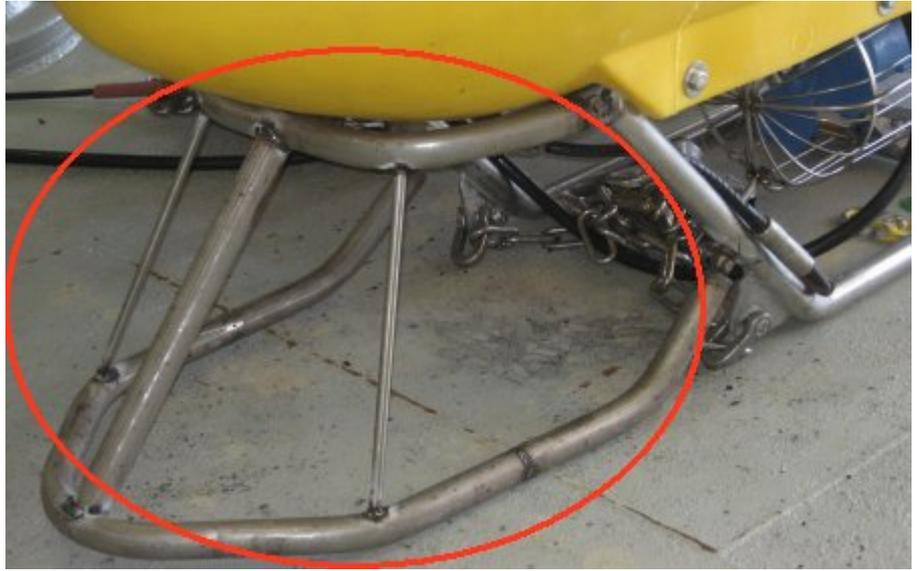
Design 4. Combined deflector and Exclusion turtle guard

This turtle guard projects forward from the tail buoy undercarriage to push turtles out of the way before they can enter the gap between the twin-fins or get stuck in the angle between the tow chains and the buoy.

This design is slightly more complex to produce but is potentially more effective as it addresses both of the potential locations for turtle entrapment outlined in Section 2.4. The gun mechanics also indicated that this design made at-sea maintenance of the tail buoy more efficient, due to being able to lift the extended front portion of the buoy on to the stern of the workboat.

Figure 12. Forward-projecting deflector turtle guard design (the added structure is circled in red)
