'TURTLE GUARDS': A METHOD TO REDUCE THE MARINE TURTLE MORTALITY OCCURRING IN CERTAIN SEISMIC SURVEY EQUIPMENT

During 2007 Ketos Ecology released a document entitled 'Reducing the fatal entrapment of marine turtles in towed seismic survey equipment' ([Ketos Ecology, 2007](#)), which outlined the issue of accidental mortality of endangered marine turtles occurring in seismic tail buoys. The document contained information on the mechanism of turtle entrapment in this equipment and made recommendations for minimising the problem via the use of 'turtle guards' that could be fitted to the front of seismic tail buoys to prevent turtles from becoming trapped. During October 2007, this document was distributed to the IAGC, the OGP and various seismic regulatory authorities with the aim of raising awareness and finding a long-term solution to the problem.

During 2008/09, it has become apparent that the turtle guards designed and implemented by certain seismic contractors do not eliminate turtle mortality in tail buoys. It also became apparent that not all designs of seismic tail buoy trap turtles; the problem is restricted to particular designs used by certain seismic contractors. Conseque

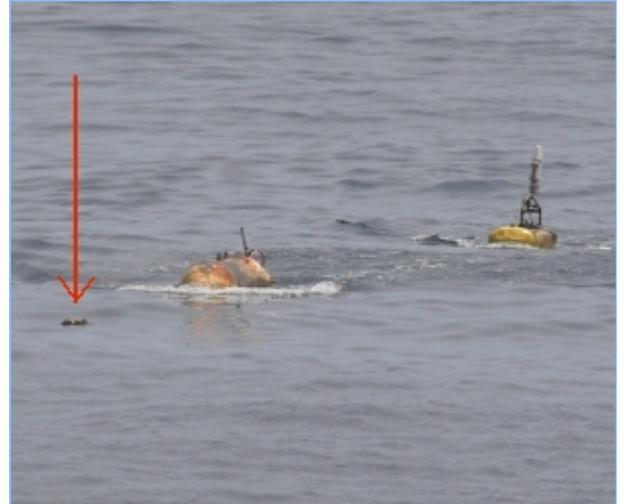
Figure 3. Basking turtle on a direct collision path with a seismic dilt float off Angola. The turtle 'startle dived' immediately (<1 m) prior to contact

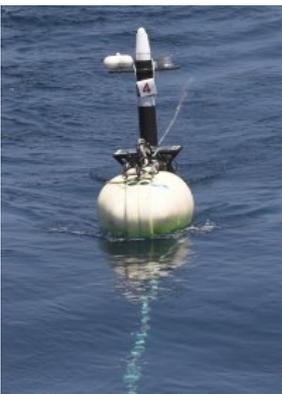
The piece of seismic equipment that almost all reported turtle entrapments have been associated with is the tail buoy. A tail buoy is a large float attached to the end of each seismic cable (Figure 4), which is used to monitor the location of the cables. The upper surface of the tail buoy is fitted with radar reflectors and Global Positioning System (GPS) receivers, and some designs also have solar panels for powering the equipment. Tail buoy designs vary, and not all seismic contractors utilise the same type. However, the tail buoys used by several of the main seismic contractors have a subsurface structure ('undercarriage') consisting of a 'twin-fin' design (Figure 5), which is used for: (a) counter-balancing the upper structure to ensure stability in the water; and (b) facilitating easy upright storage on deck. A propeller unit is housed within the undercarriage of some buoy designs to provide additional power to the unit. Towing points are located on the leading edge of each side of the undercarriage, and these are attached by chains to a swivel which leads to the stretch at the end of the seismic cable.

Figure 4. A seismic tail buoy with the tow cable visible subsurface

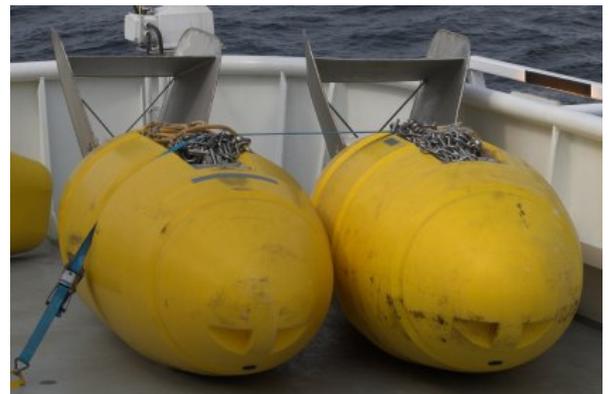
Figure 6. Two dilt floats on deck (upside down) showing the twin-fin subsurface structure

Since the twin-fin design is also used as the undercarriage of some dilt floats (Figure 6), entrapment is also a possibility in that equipment. However, on dilt floats the twin-fin is positioned towards the rear of the float rather than at the front, and turtles probably have sufficient time to move out of the way and avoid becoming trapped.

- Removing or reducing the subsurface undercarriage. This would be the most obvious solution to prevent turtle entrapment. However, it is recognised that some subsurface structure is needed to counter-balance the otherwise top-heavy design of tail buoys. The possibility of designing a buoy with a single keel should be explored, particularly since the presence of solar panels on most buoys now reduces the need for the underwater propeller unit (at least in the sub-tropical and tropical waters where the highest turtle densities occur). The advantage that the twin-fin design offers for upright storage is considered surplus since it is not utilised on many ships (see Figure 6)

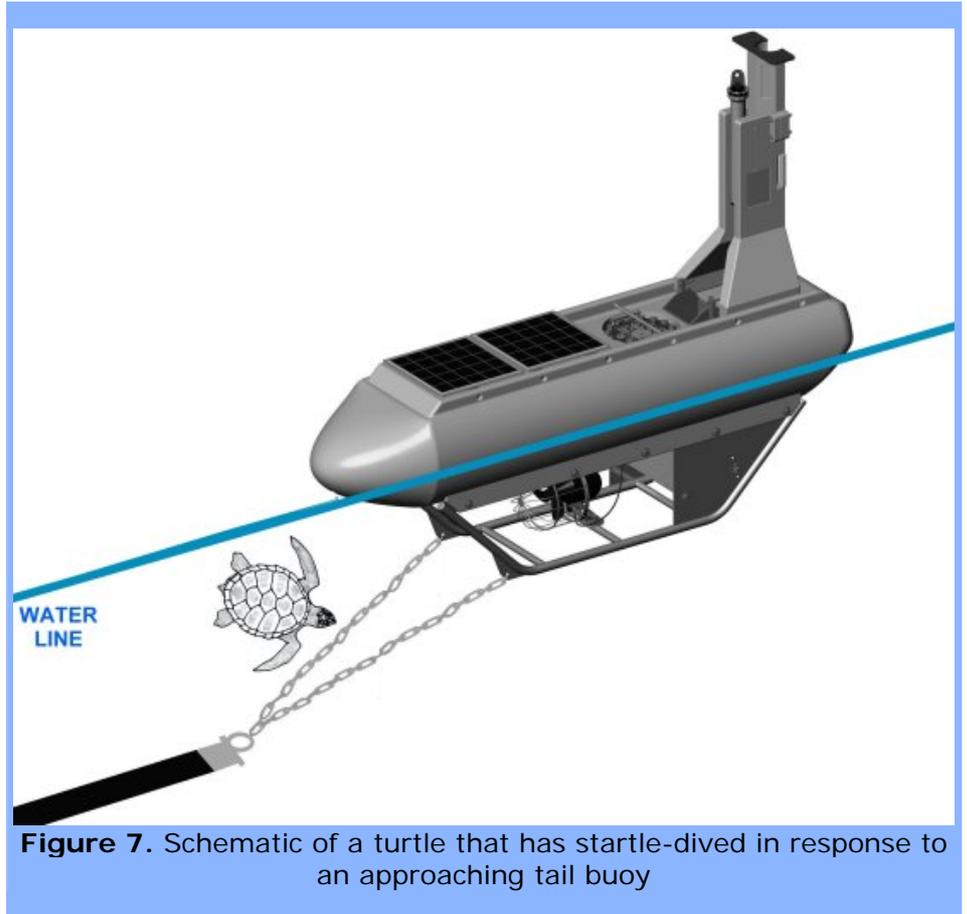
Figure 7. Schematic of a turtle that has startle-dived in response to an approaching tail buoy

A turtle that startle dives in response to an approaching tail buoy will be in a prime position for entrapment (Figure 7).

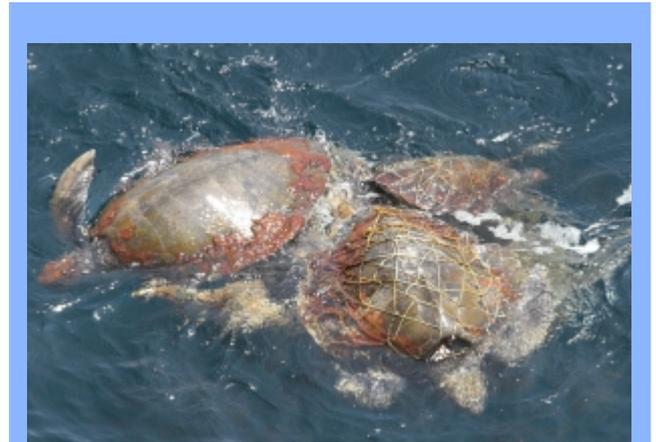
Figure 8A. Several olive ridley and green turtles trapped in fishing net, photographed from a seismic vessel off Equatorial Guinea (© C. Weir). This situation is fatal for turtles.

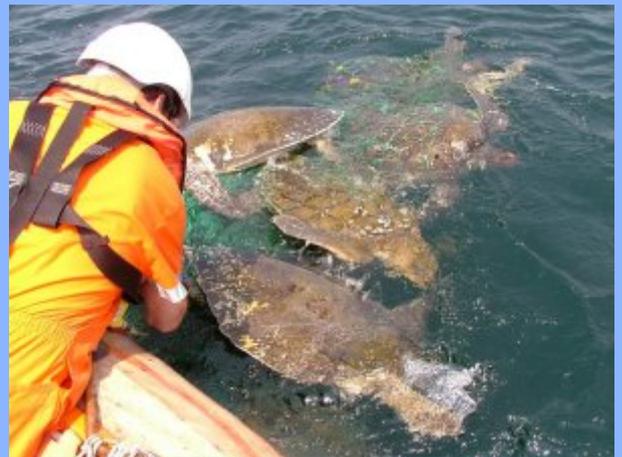
Figure 8B. A seismic crew cut free six turtles entangled in fishing net off Congo (© M. Unwin)
